QUINNIPIAC RIVER BASIN
PROSPECT , CONNECTICUT

CHESHIRE RESERVOIR DAM
CT 00303

PHASE I INSPECTION REPORT
NATIONAL DAM INSPECTION PROGRAM

APRIL 1980

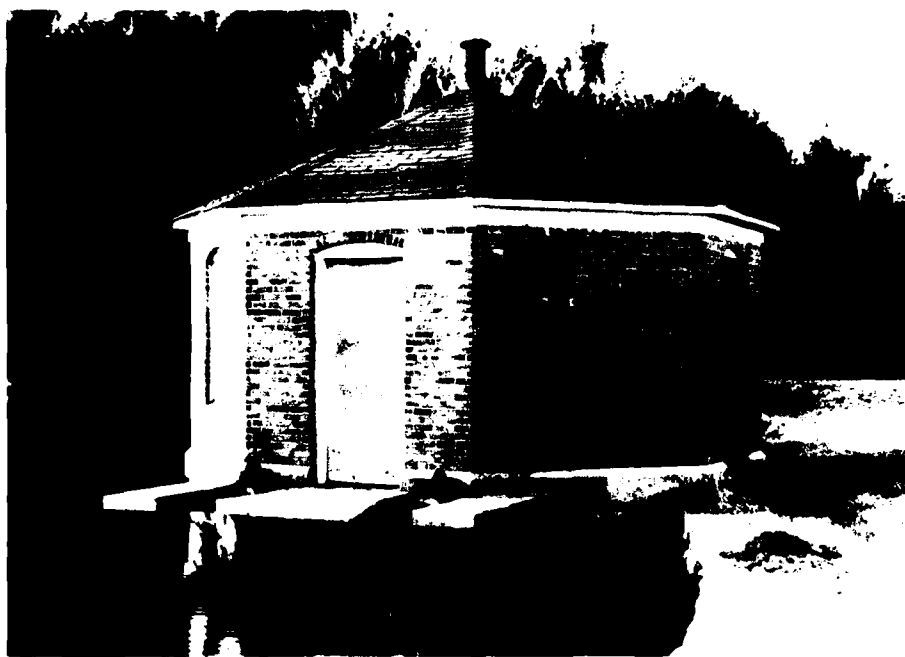
PHOTO #11: Gatehouse.
